# Bainbridge Island Nearshore Structure Inventory

*Peter Namtvedt Best*

*City of Bainbridge Island*

*Department of Planning and Community Development*

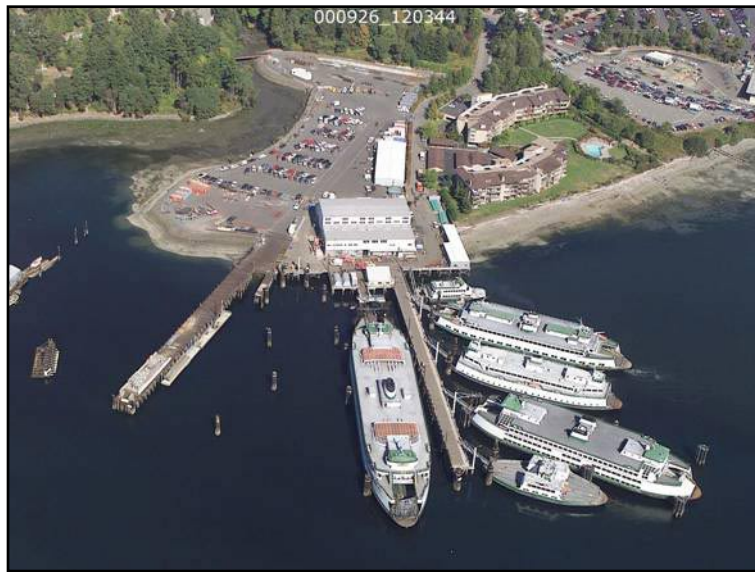
**Figure 3.** Washington State Ferries' Repair and Maintenance Facility. (© WA Dept of Ecology 2000)

Bainbridge Island makes for an interesting area of study for many reasons, including that it is a fairly large island with self-contained watershed and shoreline systems, it exhibits both urban and rural shoreline development characteristics, and it is under the jurisdiction of a single local government. As a general pattern, population density is concentrated in the city's urban core located on the northern shore of Eagle Harbor and along much of the remainder of the Island's shorelines. While not a measure of "buildout," approximately 82 to 85% of shoreline parcels have been developed to some extent, but areas of lower densities and park lands remain. Shoreline uses are primarily single-family residential, with commercial and industrial uses concentrated primarily in Eagle Harbor. The Island's shorelines host two state parks and several local parks, a large fish pen aquaculture facility, the Washington State Ferries' Maintenance and Repair Facility, the second busiest ferry terminal in the state, many marinas, and the historic legacy of large sawmills, ship yards, and a federal Superfund site that was a large creosote wood treatment facility (Figures 2-4).

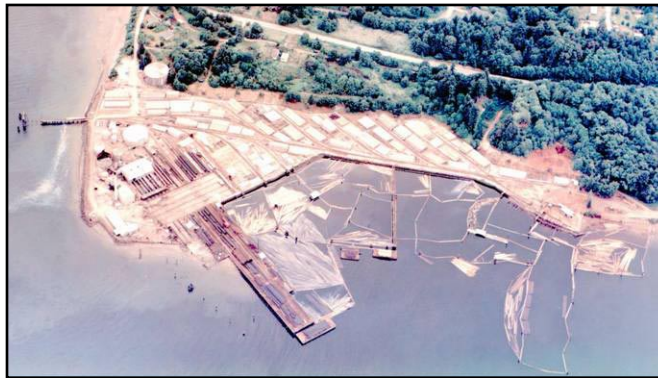
**Figure 4.** Wycoff Creosote Plant in operation before being designated a Superfund Cleanup Site. (© WA Dept of Ecology 1977)

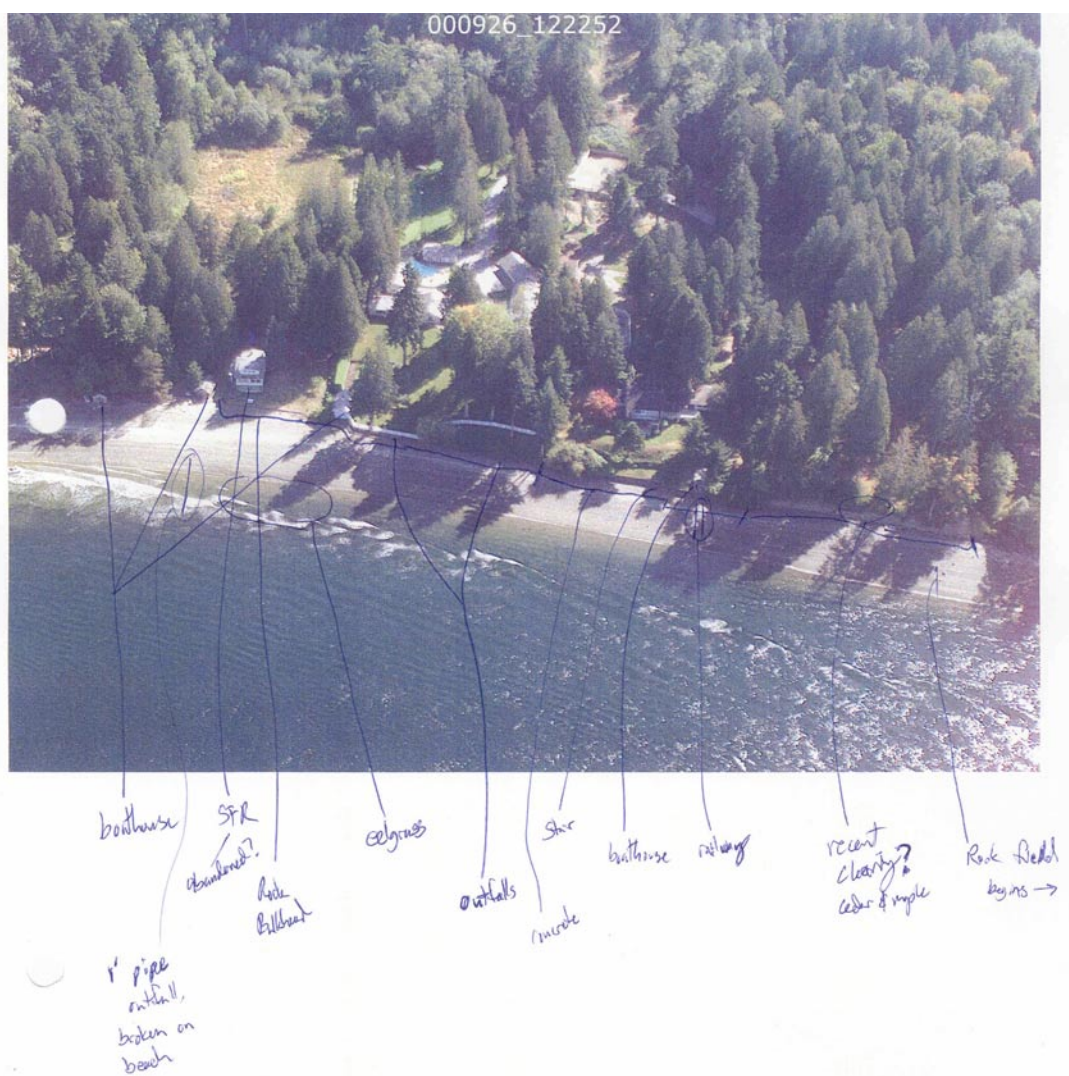
**Figure 5.** Field-Annotated Oblique Aerial Photograph (© WA Dept of Ecology 2000)

Our inventory methodology called for the field annotation of over 600 digital oblique aerial photographs (Ecology 2000b) that were taken at fairly close range and high resolution. Photographs were annotated to improve photo interpretation, allow for QA/QC of some data, and record changes since the photographs had been taken (Figure 5). Since the city did not own the GPS systems used and had no prior experience with them, all crew members were trained to use the equipment and complete the attribute information correctly. The inventory methods were also field tested.

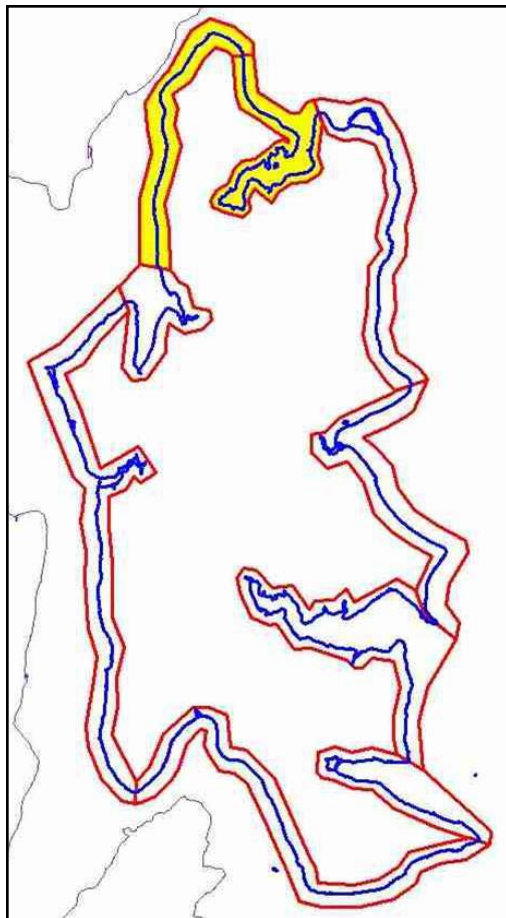
**Figure 7.** Areas of detailed comparison (highlighted)

Considering that ShoreZone used 10 percent increments for classification, ShoreZone appears to have fairly accurately estimated total shoreline modifications and underestimated overhanging riparian vegetation at first comparison. But with almost 5 miles difference in the total shoreline length, largely due to the significant sinuosity of the ordinary high water mark (OHWM) inventoried by the city, there was concern that the small jogs along the OHWM could either dilute or overemphasize the city's results when directly compared to ShoreZone (Figure 6). Therefore, the city's data was normalized to the ShoreZone shoreline by transposing beginning and end points of the city's data and recalculating the length of the ShoreZone shoreline between those two points. This data normalization required hand digitization, so the comparison was limited to 36 ShoreZone reaches within two of the city's Shoreline Management Areas (Williams et al. 2003; Williams et al. in prep), one of which was an area of open shoreline with less variance between the shapes of the two shorelines while the other was an embayment with greater variance between the two shorelines (Figure 7).

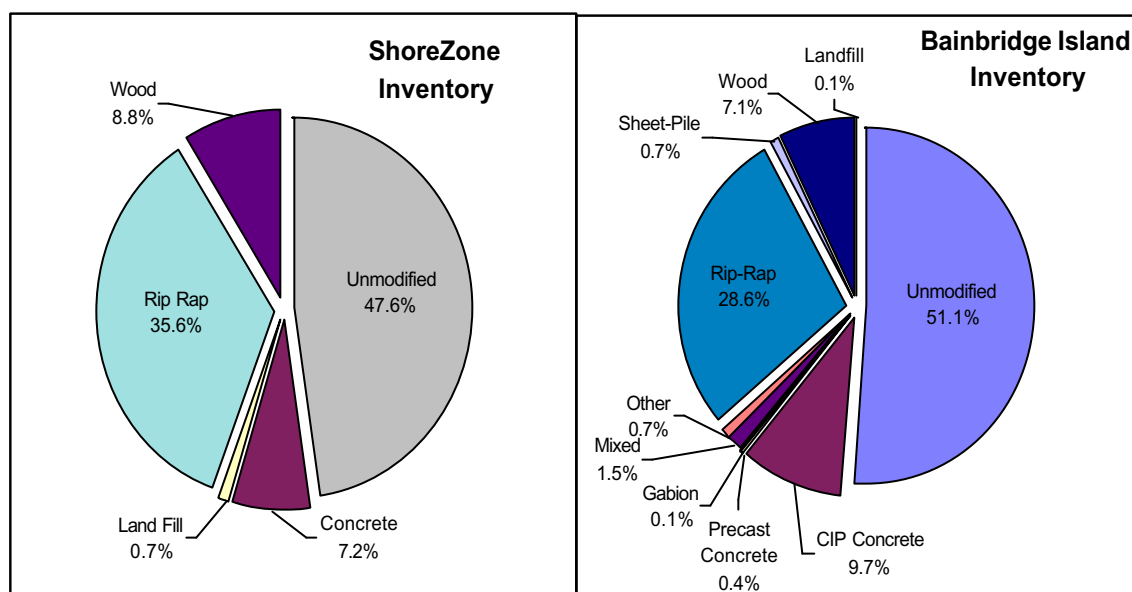
**Figure 8.** Detailed Comparison of Shoreline Modification.

Figure 8 provides a closer look at the ground truthing of shoreline modifications as documented by ShoreZone. ShoreZone documented primary, secondary, and tertiary shoreline modifications as percentage estimates of total unit length in ten-percent increments, which were used to calculate relative linear lengths. While a direct comparison is not appropriate because ShoreZone was restricted to the three most prevalent types of shoreline modifications, it seems appropriate to identify that there are noticeable overestimates of landfill and rip-rap and a noticeable underestimate of concrete-types. These discrepancies, however, do not seem adequate to raise significant suspicions in the total shoreline modification estimates of ShoreZone at broader landscape scales. Further comparison at the individual ShoreZone “unit” scale would provide a more thorough picture of ShoreZone variability and appropriate landscape-scale reliability.
